Manhole Inspection Summary

Manhole # S03II2012MH

Location Address: **2907 FALLSTAFF RD**

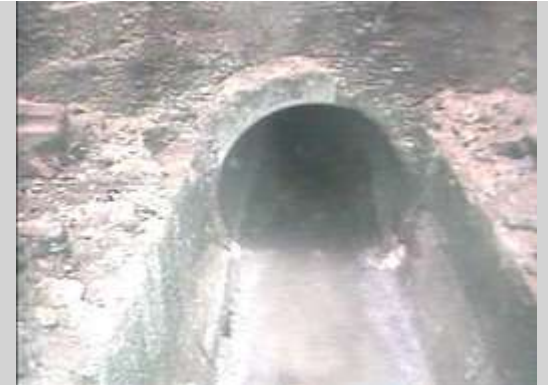
10 in. Circular Gravity Sewer Pipe Out @ 12 O'Clock

Pipe Material: **Clay** ☐ Pipe Lined

Invert Depth: **11.56** (ft.) Flow Characteristics: **Fast**

Infiltration: **Evidence** Pipe Seal Cond: **Broken**

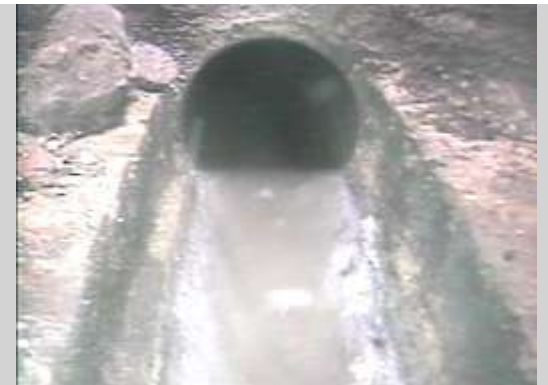
10 in. Circular Gravity Sewer Pipe In @ 6 O'Clock

Pipe Material: **Clay** ☐ Pipe Lined

Invert Depth: **11.35** (ft.) Flow Characteristics: **Fast**

Infiltration: **None** Pipe Seal Cond: **Unknown**
